## **Non Kel-Cell pumps Diaphragm failure due to Cavitation / Starvation**

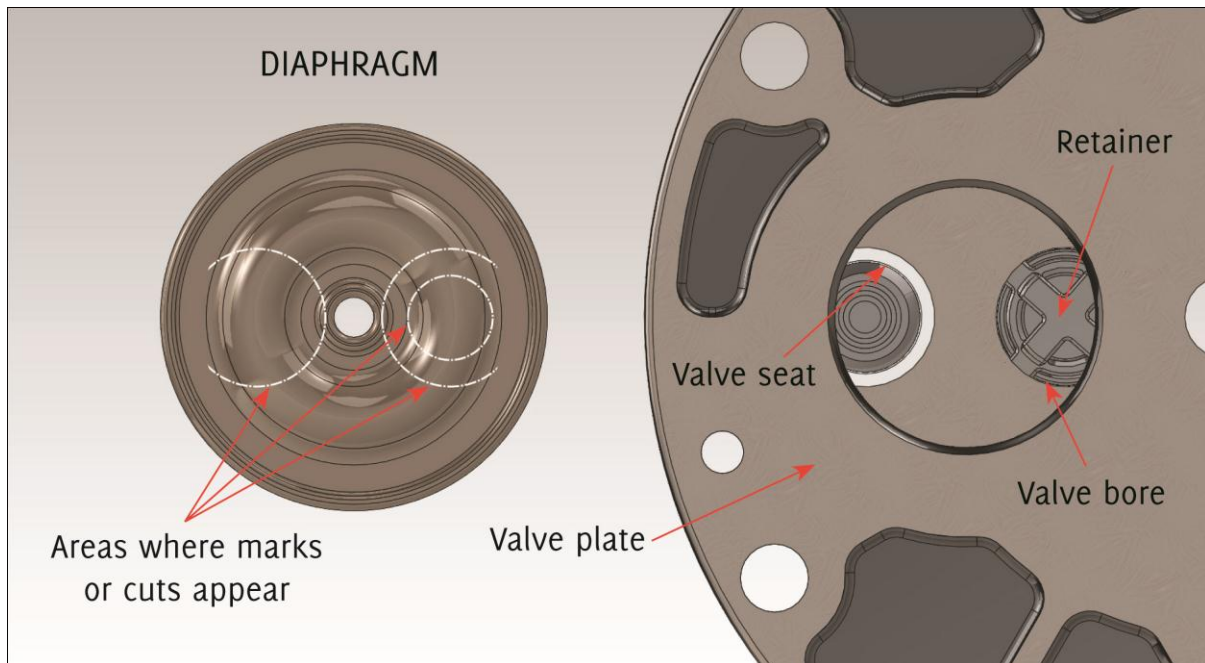
If a non Kel-Cell Hydra-Cell pump has been allowed to cavitate, or the fluid supply has been restricted or blocked, the diaphragm will move forwards until it is pushed against the of the bores in which the valve assemblies are fitted.

This will result in marks on the face of the diaphragm in the corresponding position to the edges of the bores in the valve plate, or even the centres of the valve seats of the discharge valves. If the effect is strong enough, the diaphragm may also be cut in the same positions.

This effect may appear on only one or two diaphragms and the marks or cuts may only correspond to one the valve bores of the affected pumping chamber.

Sometimes, the marks will appear only as a slightly roughened surface texture and maybe difficult to spot in normal light.

If there are any marks or changes to the surface of the diaphragm material in these positions then cavitation is almost certainly the cause. Investigation of the inlet condition should be the first course of action to prevent recurrence.
